**RE: Test Pit Summary Report
Thorndike Place Stormwater Peer Review**

TEST PIT SUMMARY REPORT

**THORNDIKE PLACE
DOROTHY ROAD
ARLINGTON, MA**

JULY 2023

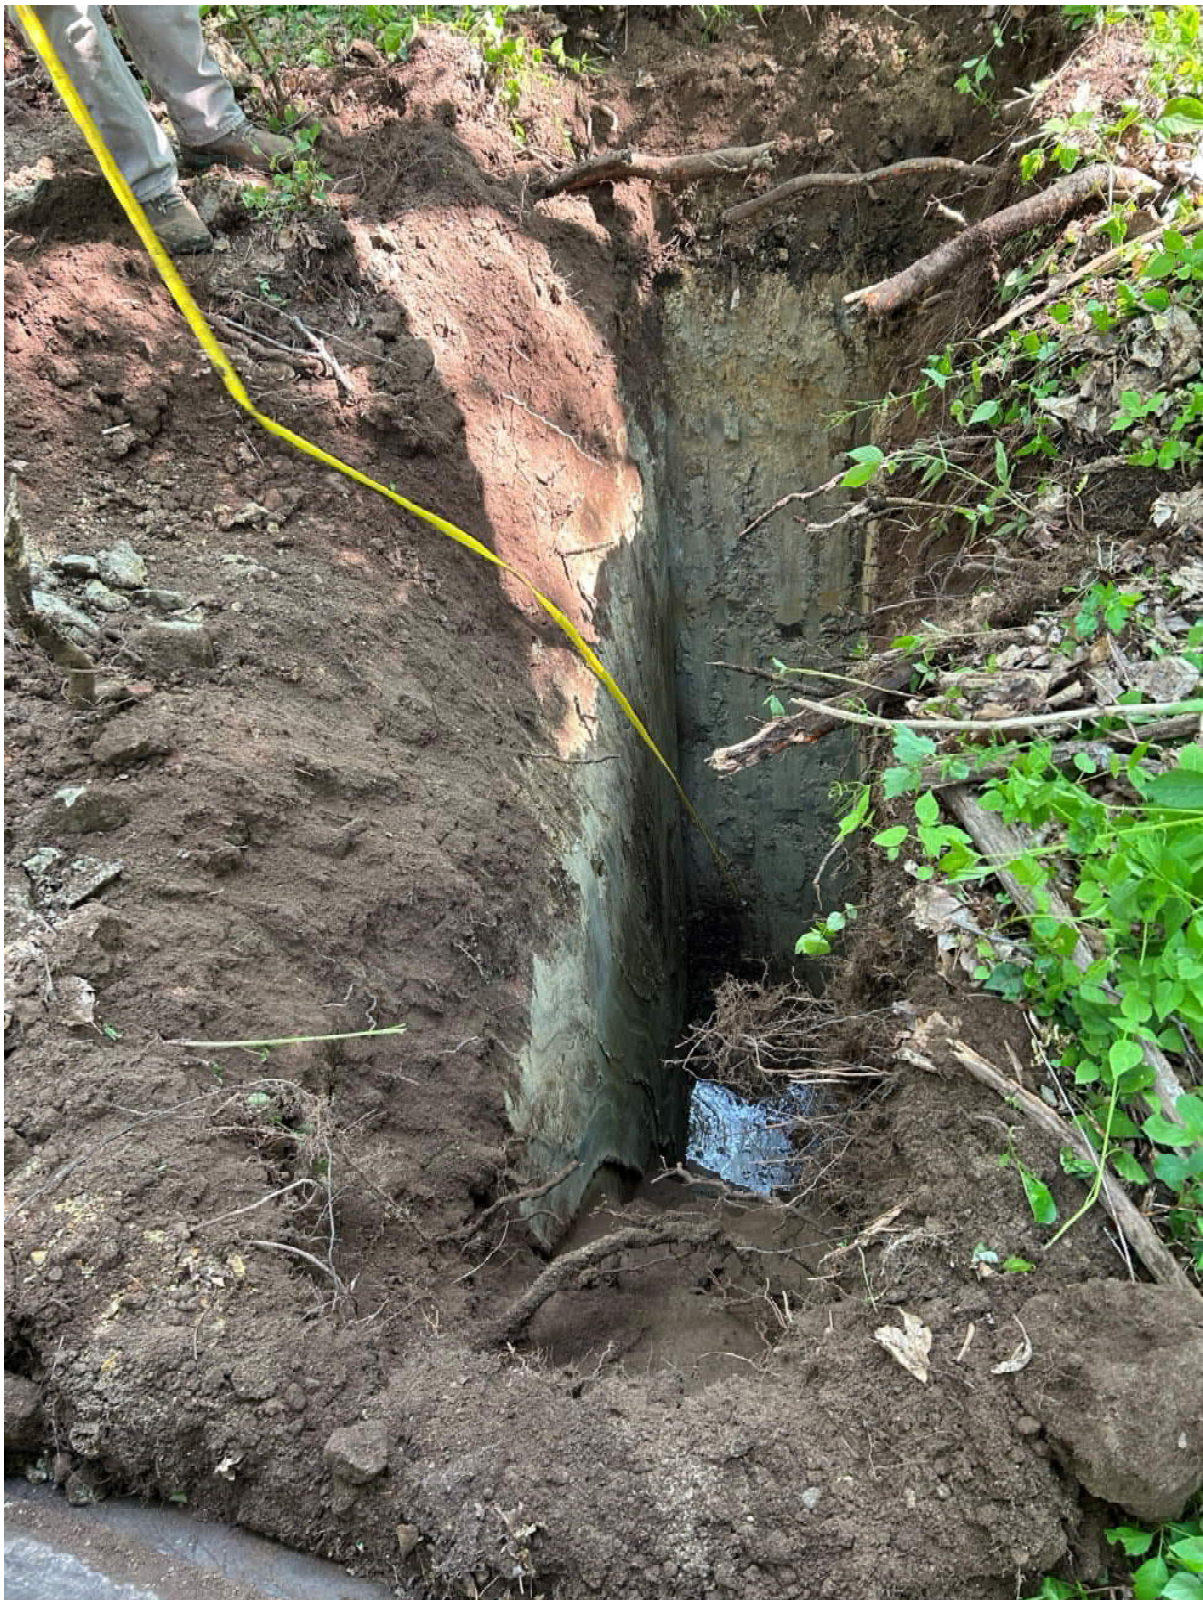
TP-6 with standing water at bottom. Note redoximorphic features on side wall.

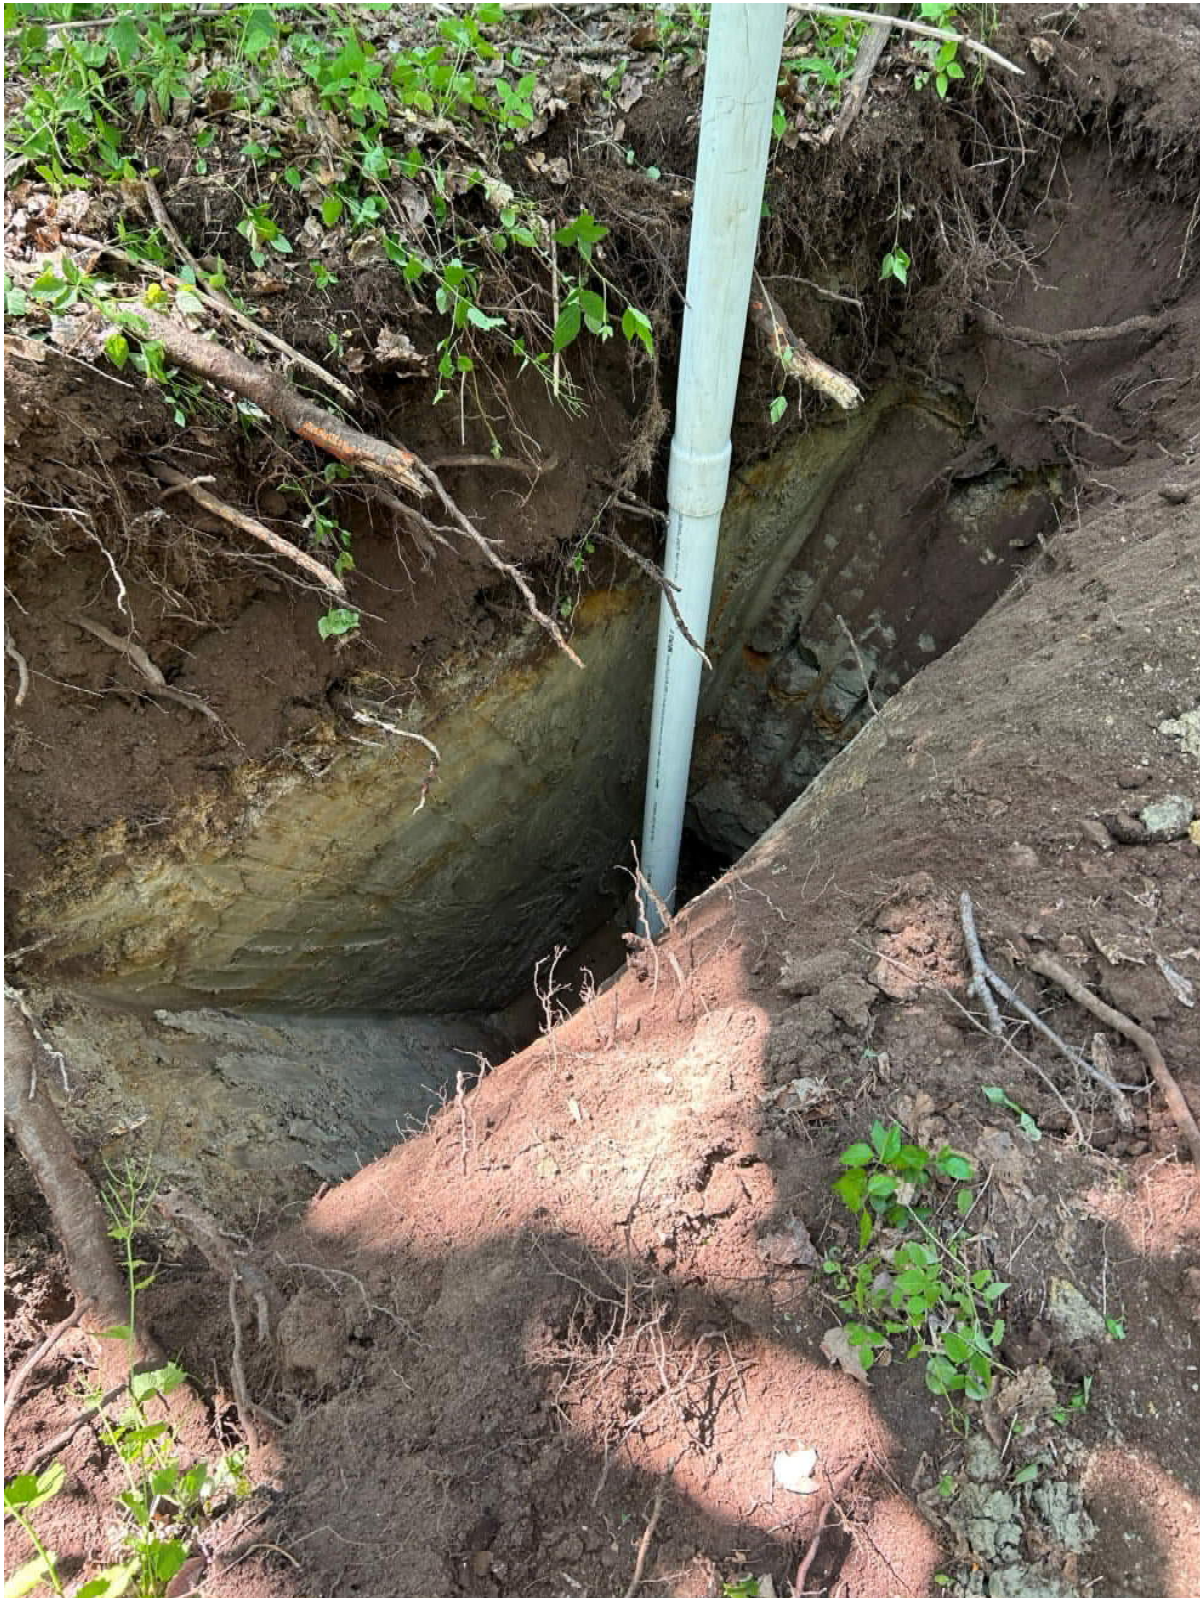
TP-6 monitoring well installation. Note redoximorphic features on side wall.

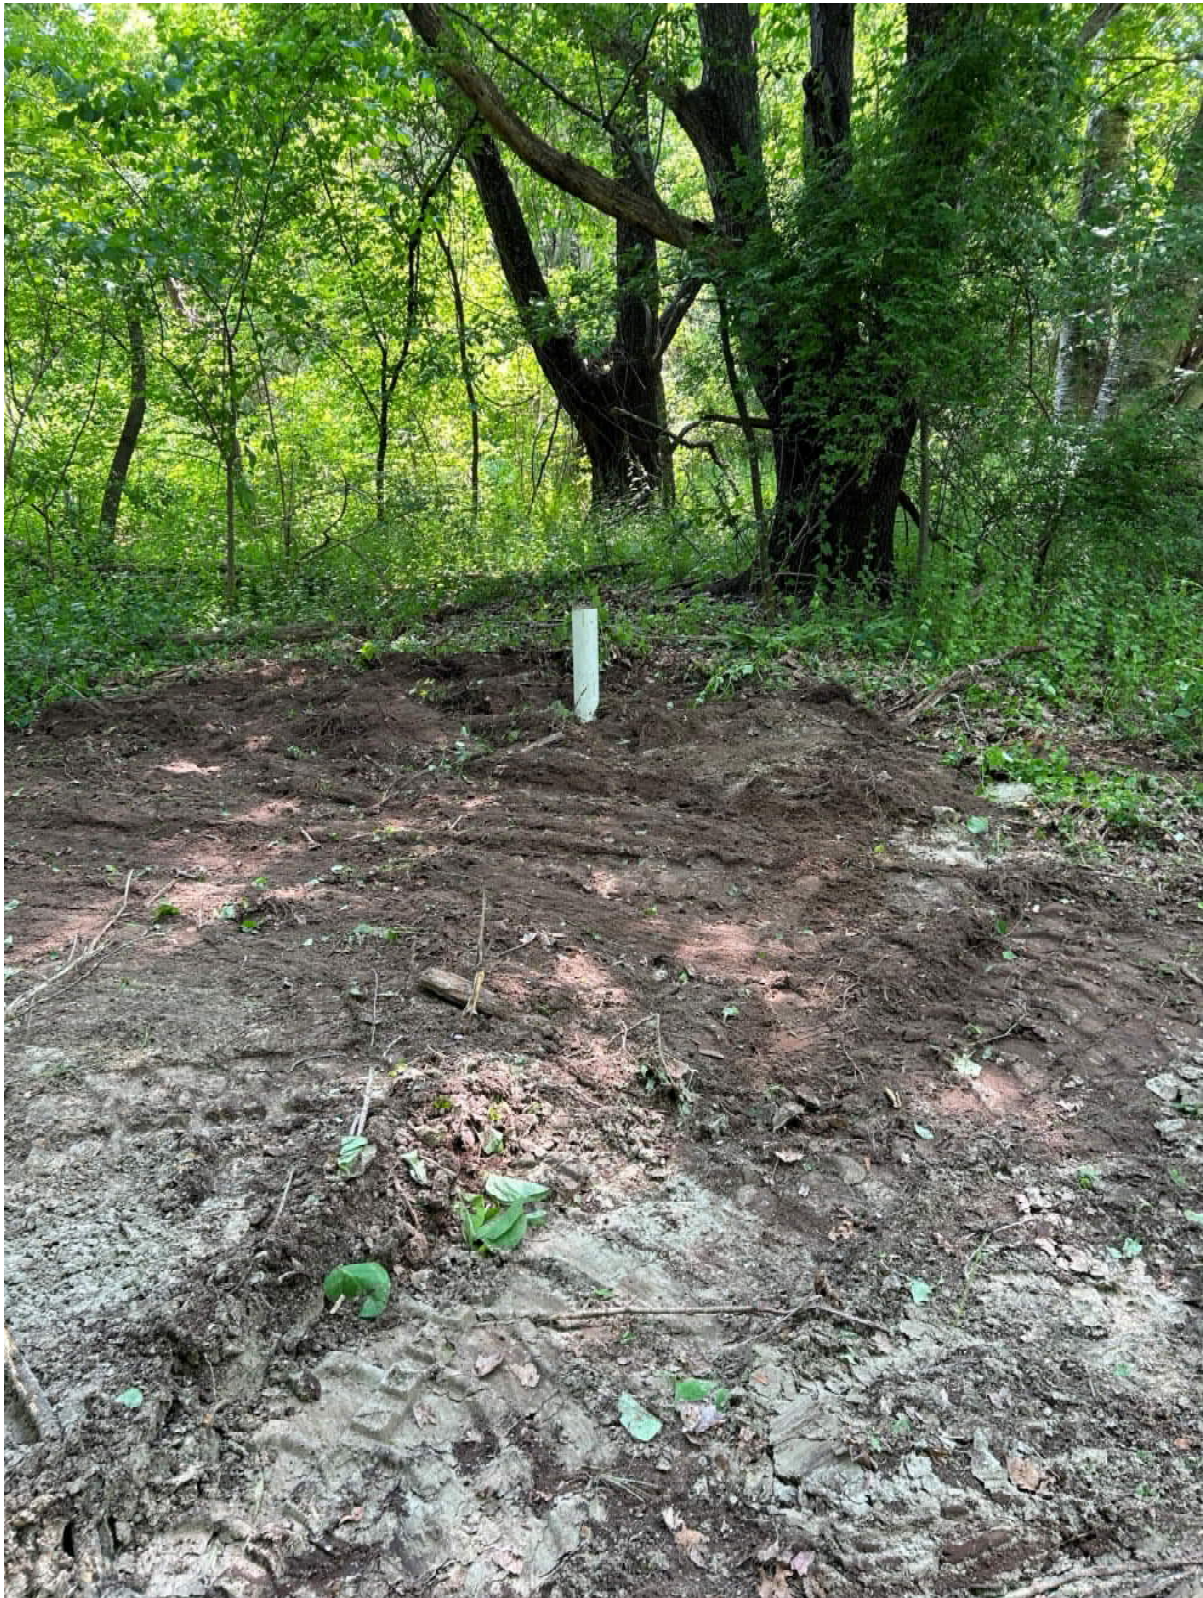
Completed monitoring well at TP-6

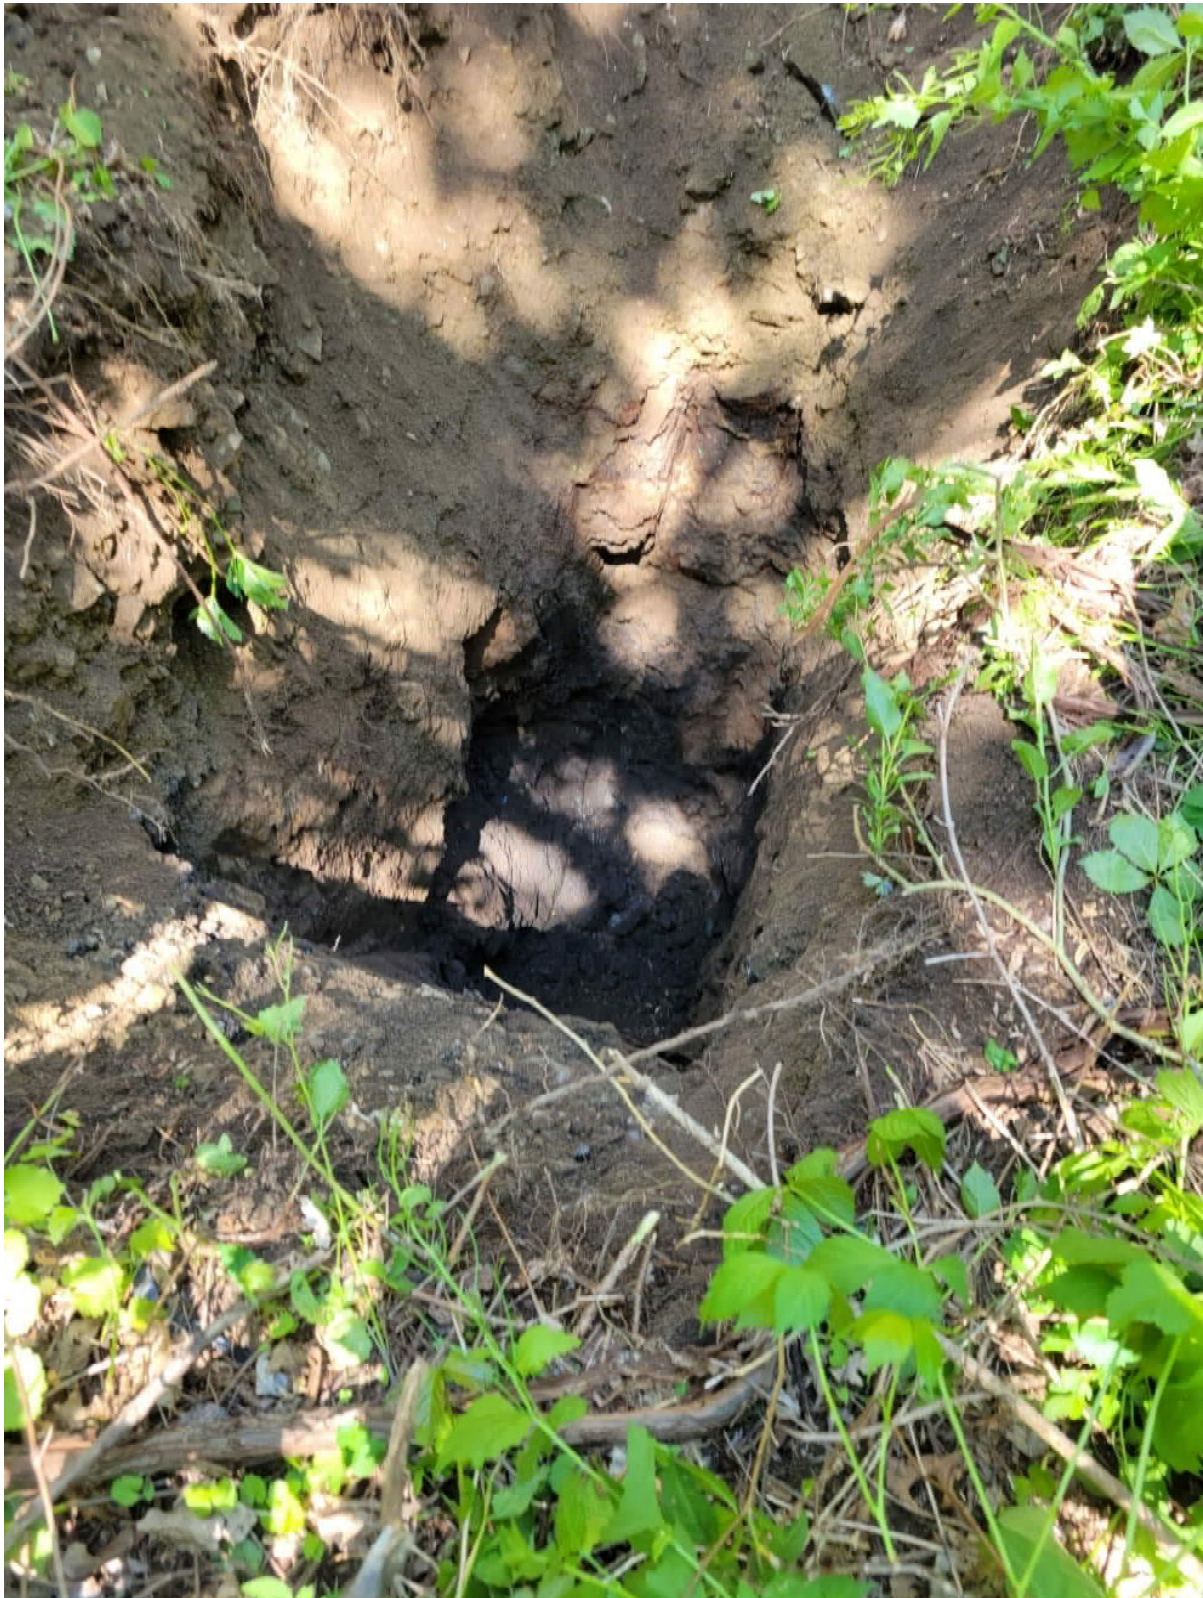
TP-7 at full depth

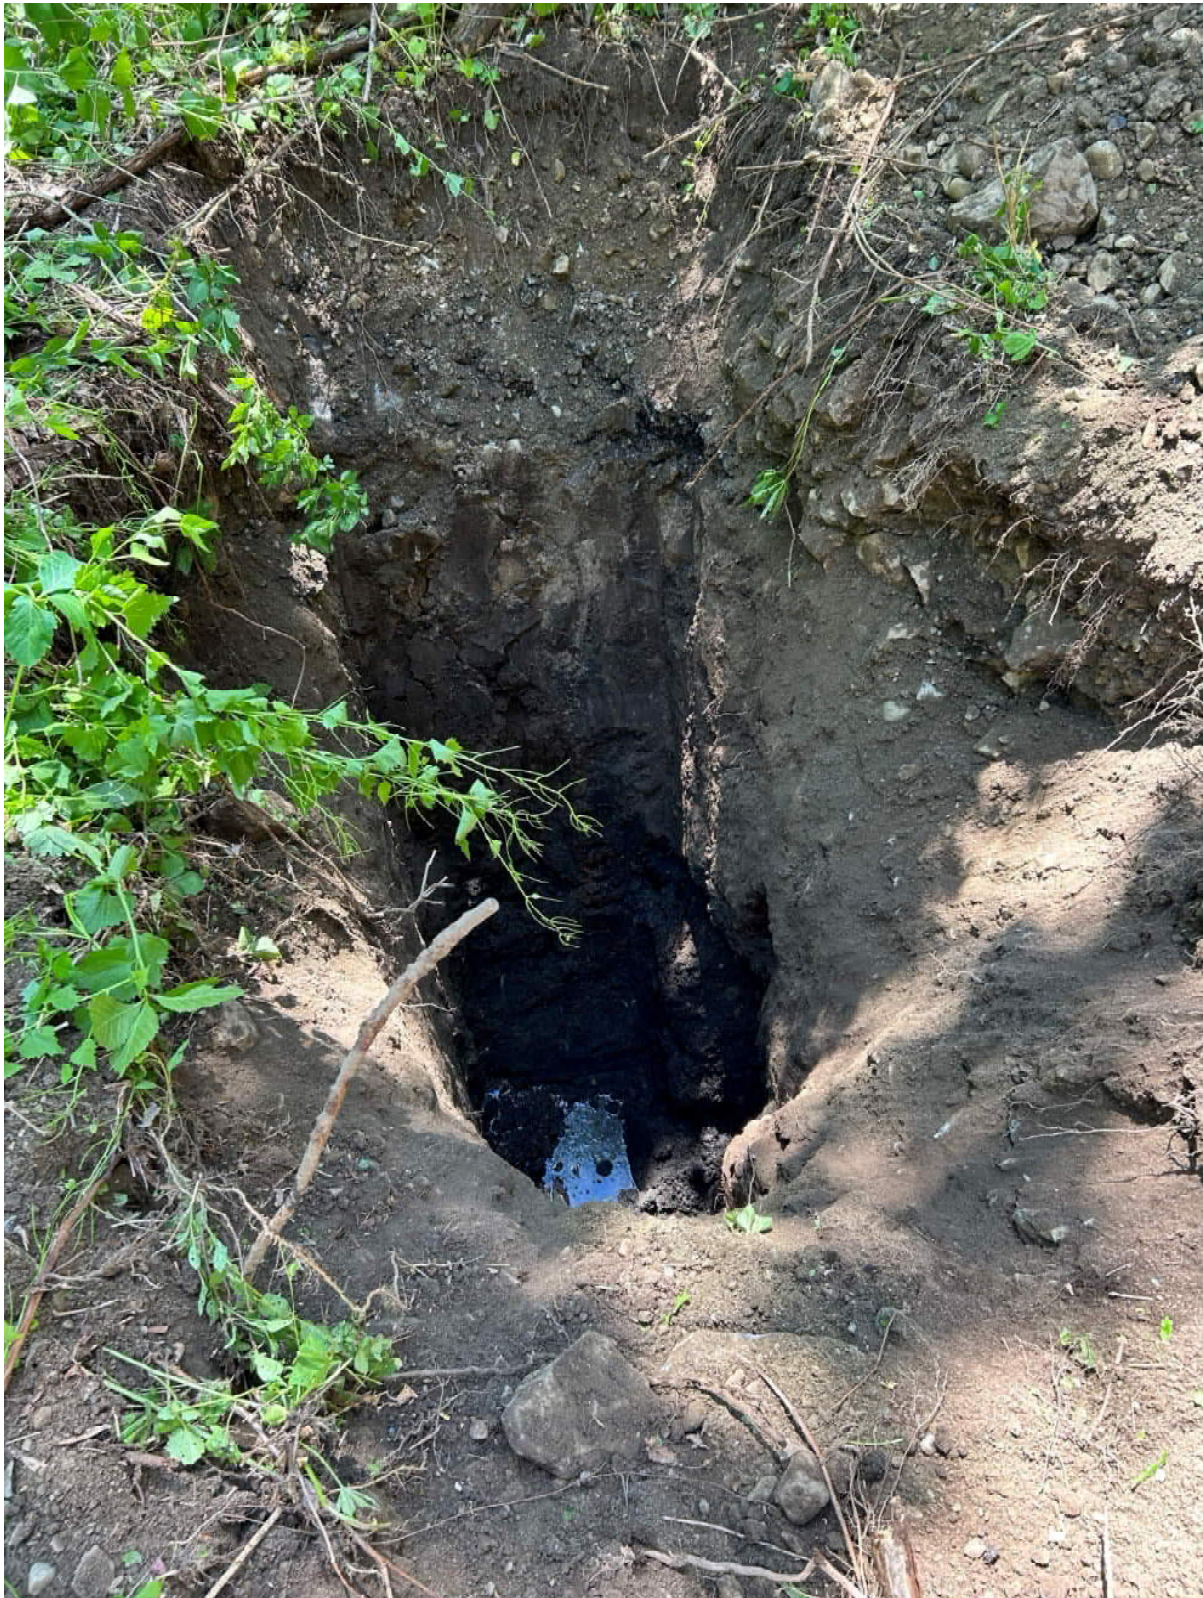
TP-7 with standing water at bottom

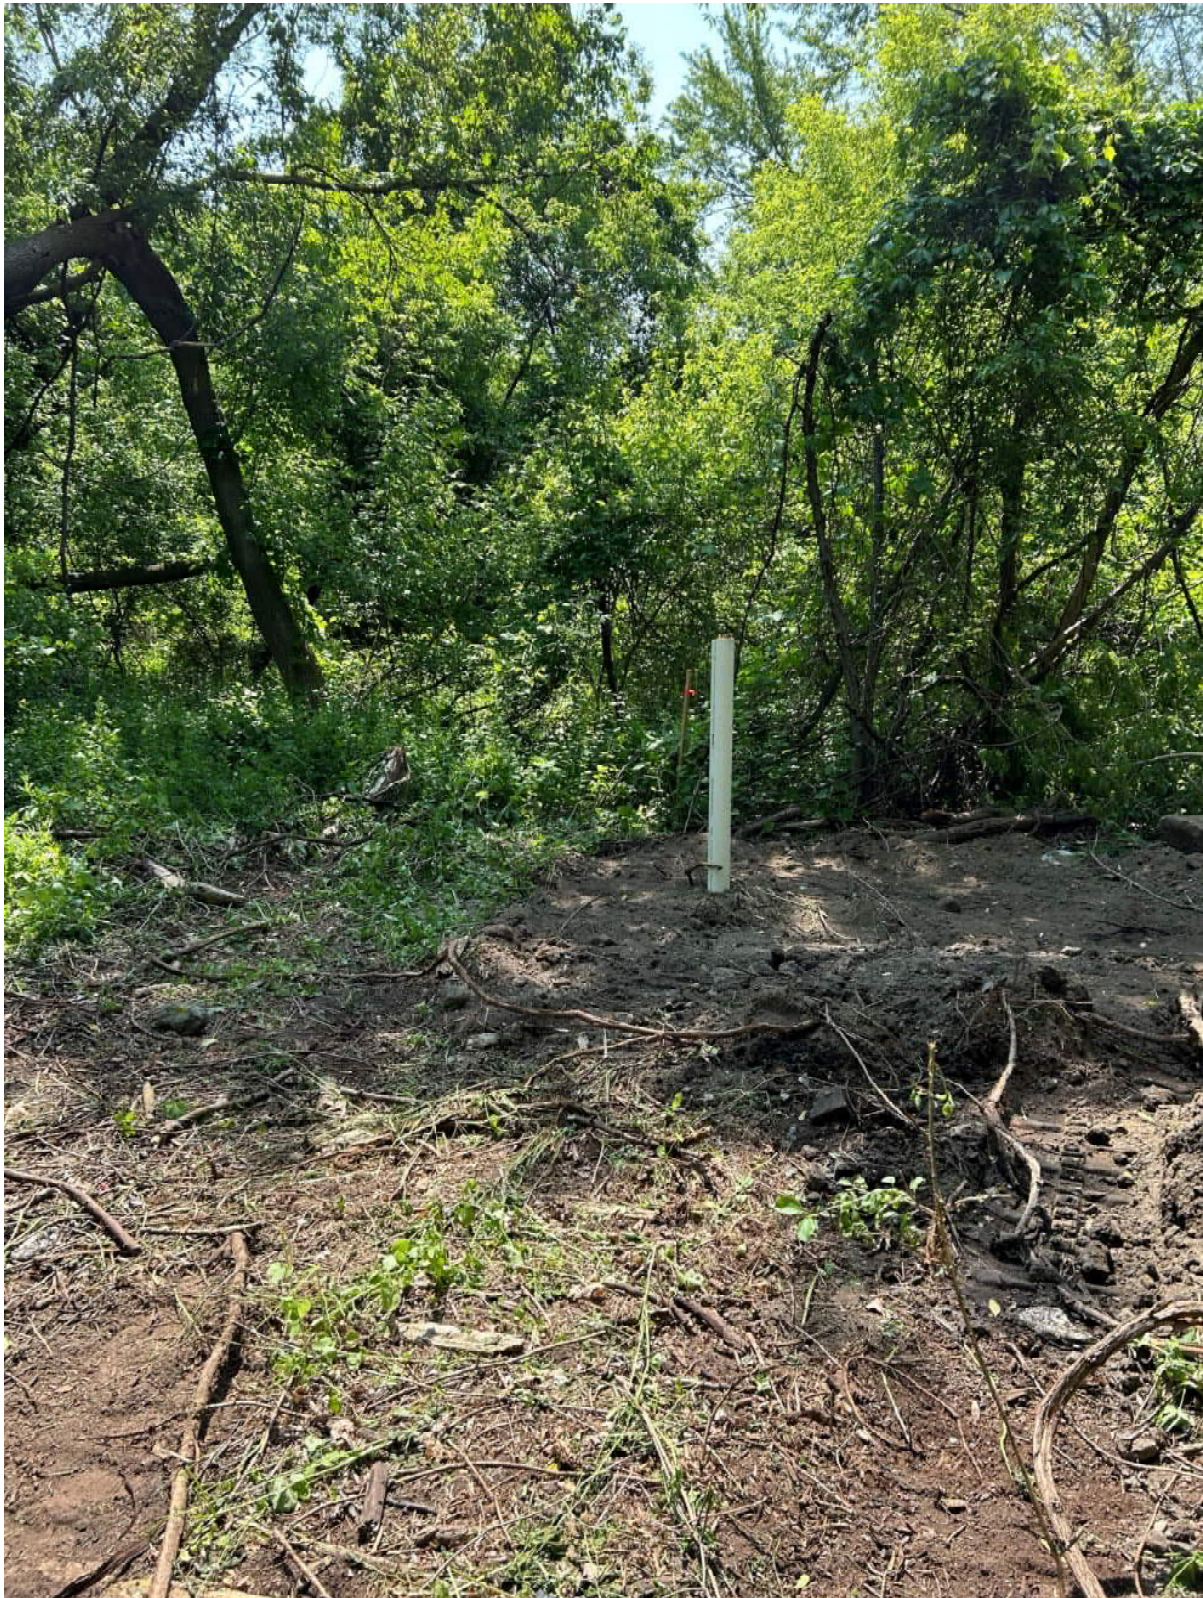
Completed monitoring well at TP-7
